UNITED STATES
DEPARTMENT OF THE INTERIOR
BUREAU OF RECLAMATION

HYDRAULIC MODEL STUDIES OF THE MODIFIED
OUTLET WORKS STILLING BASIN
NAVAJO DAM
COLORADO RIVER STORAGE PROJECT
NEW MEXICO

Report No. Hyd-573

June 15, 1967

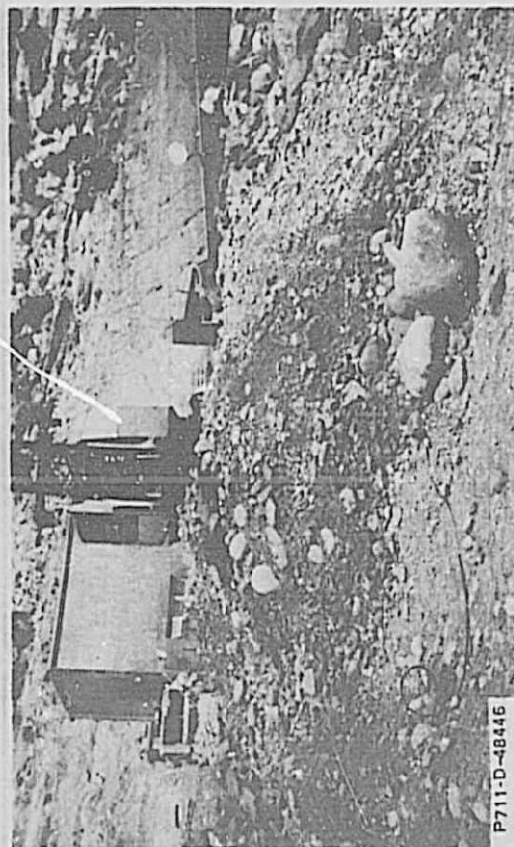
Reinforcement bars were bent across the basin and two large rocks were found wedged in the dentates. The divers removed about 10 gallons of material up to 8 inches in diameter. Some scattered debris in the area of the bent up bars could not be removed.

Material removed from stilling basin.

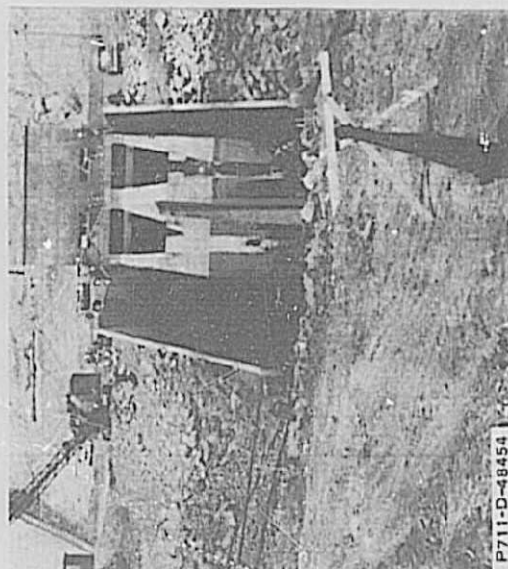
Severe erosion up to 5 feet deep was disclosed in the floor and through two layers of reinforcement steel in the walls. Reinforcing bars were exposed, broken, and bent. A cofferdam was built downstream from the basin, the basin was unwatered, and a complete inspection was made on May 3, 1965. The damage shown in Figure 7 was described in the Travel Report of the Head, Spillways and Outlet Works Section:

"The damage was even more extensive than reported by the divers with erosion exposing reinforcement over half the height of the center wall. Erosion had extended through the top layer of reinforcement at the 30° slopes just downstream of the hollow-jet valves and loose cobbles were trapped behind the reinforcement at the upper end of these slopes. These cobbles were deposited by the turbulent flows in the basin and indicate that gravel and cobbles in the basin caused the extensive erosion damage.

"The most severe damage occurred in the left side of the basin at the upstream end of the floor and center wall. Two layers of No. 11 bars at 6-inch spacing in the wall were broken and bent downstream along with No. 9 and No. 8 bars at 6-inch spacing in the top of the floor slab. The horizontal floor bars at the base of the wall had loosened sufficiently to allow flow of water from one side of the wall to the other. On the right side of the center wall the No. 11 bars were exposed and loosened but not removed. It appeared that many of the bars could be salvaged by bending back into position. Some new bars need to be spliced and welded to the existing bars. About 70 cubic yards of new concrete will be needed to replace the eroded concrete in the floor and walls upstream from the downstream end of the center wall. A few bars were exposed in the dentated sill and should be repaired.

Overall view of damaged basin.

Temporary repairs were made to the stilling basin in May of 1965. The original basin outline was restored by bonding new concrete to the damaged areas with epoxy. Intermittent outlet works operation was resumed on May 24 and continued until June 3 at valve openings between 16 and 75 percent; the reservoir varied from elevation 5975 (255 feet) to elevation 5980 (260 feet) during this period. On June 3, the valve openings were increased to 100 percent and the outlet works operated intermittently, usually 100 percent open, through July 10, 1965 (see Figure 6). The longest period of sustained operation at 100 percent valve opening was 5 days. The reservoir rose to elevation 6002 (282 feet of head) between June 3 and July 10. Figure 8 shows representative flow conditions during this period.

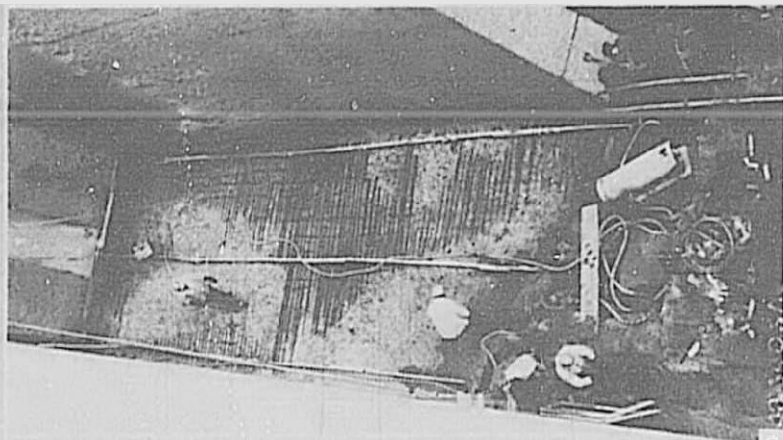
Damage in right bay.

NAVAJO DAM OUTLET WORKS
Original Configuration
Damage in Prototype Stilling Basin

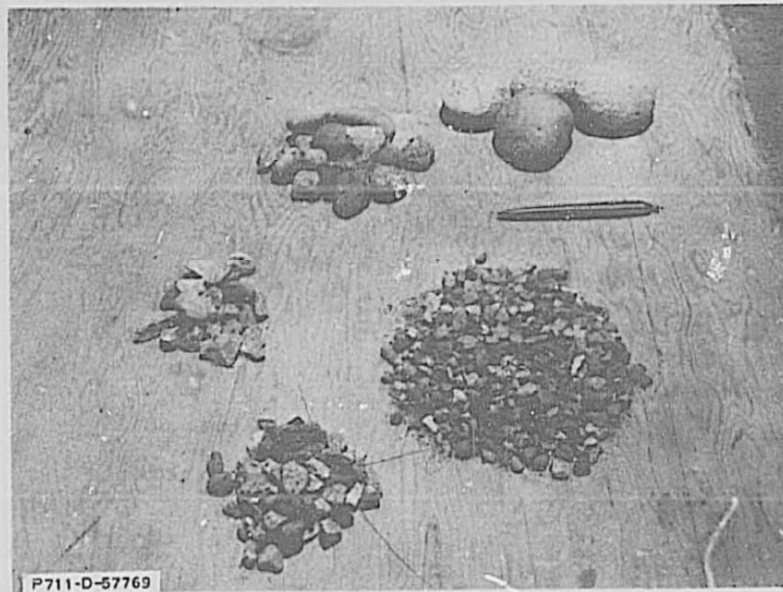
A. Material placed in basin for abrasion test.

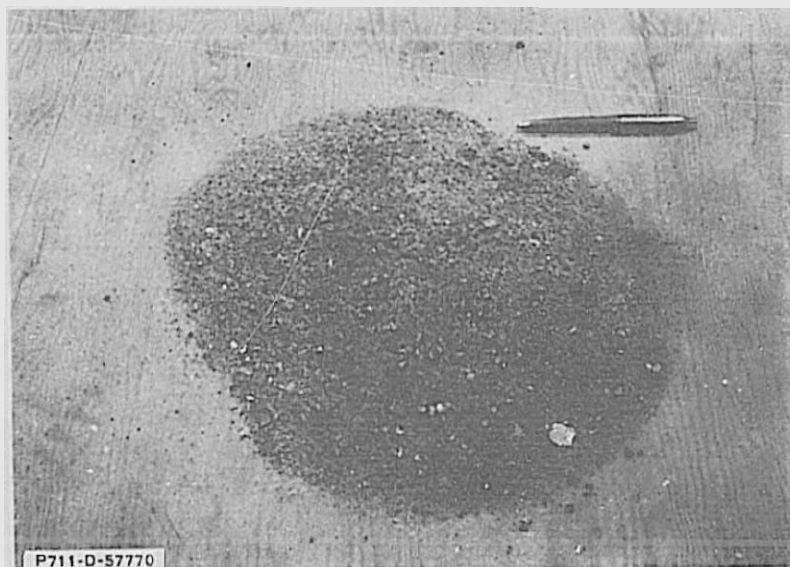
B. Sand pulled into basin during abrasion test.

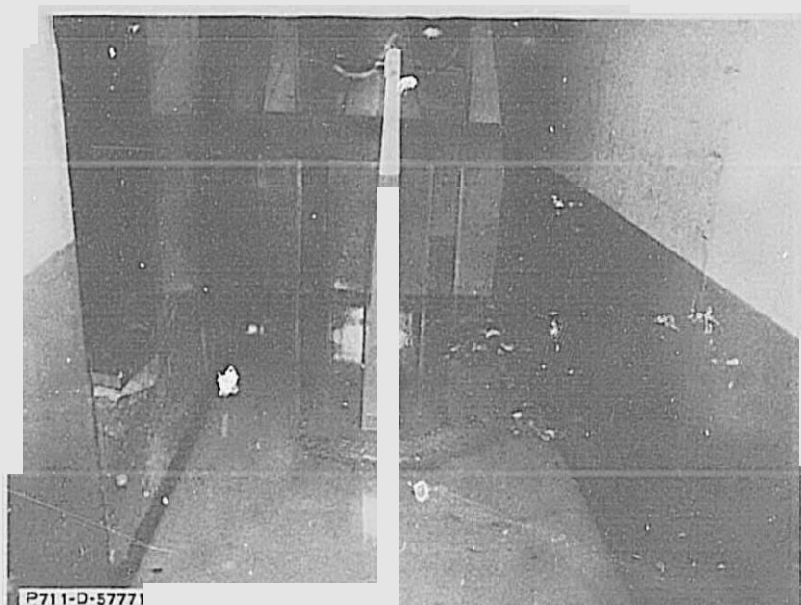
Material in stilling basin and damage after 4 hours
operation at Q of 1,840 cfs, reservoir elevation 5965,
both valves 32 percent open, tailwater elevation 5714.4.

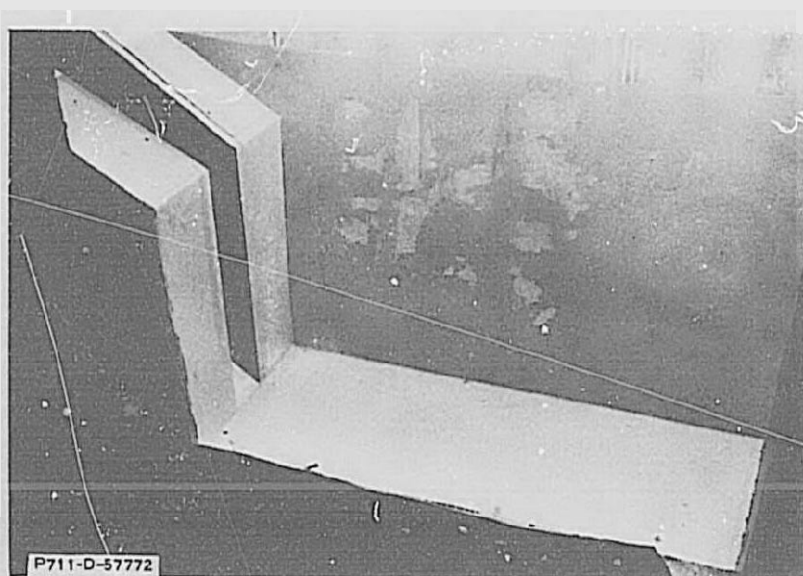
Damage in right bay of stilling basin.

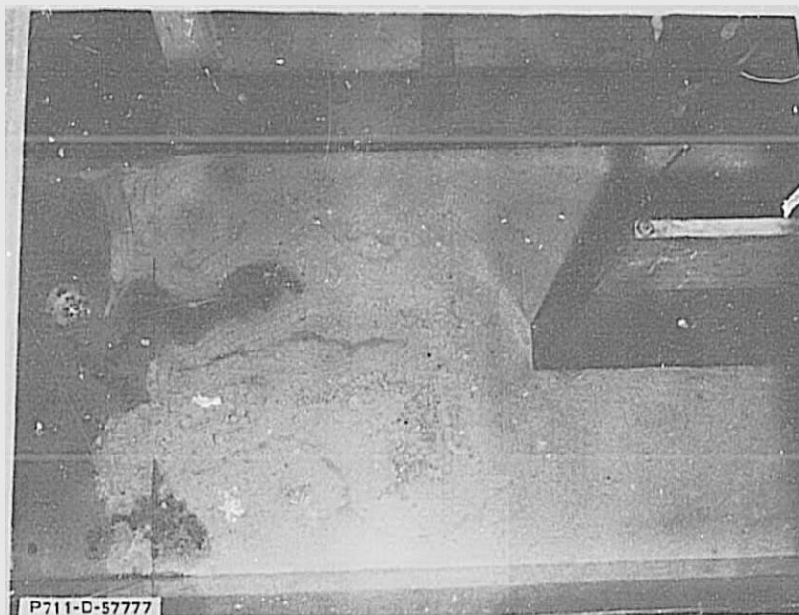
Material in stilling basin after 4 hours operation
at Q of 3,940 cfs (Figure 14).

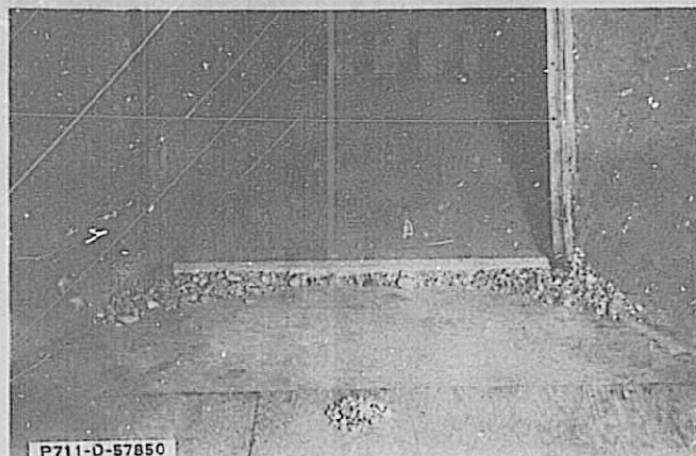
A. Preliminary 18-inch-deep rock trap. Photograph shows material caught in trap and material which entered basin during operation at Q of 3, 200 cfs.

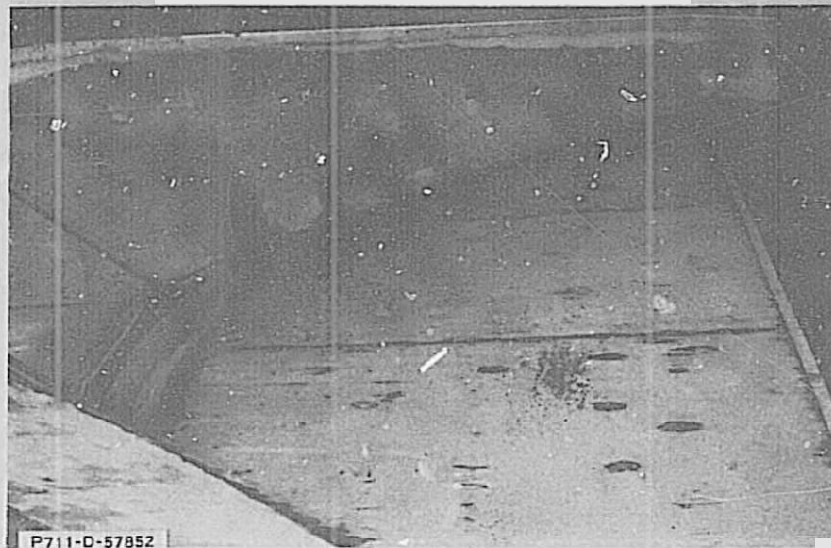
C. Material location after operation at Q of 3, 200 cfs with 36-inch rock trap. No material was found in the basin.

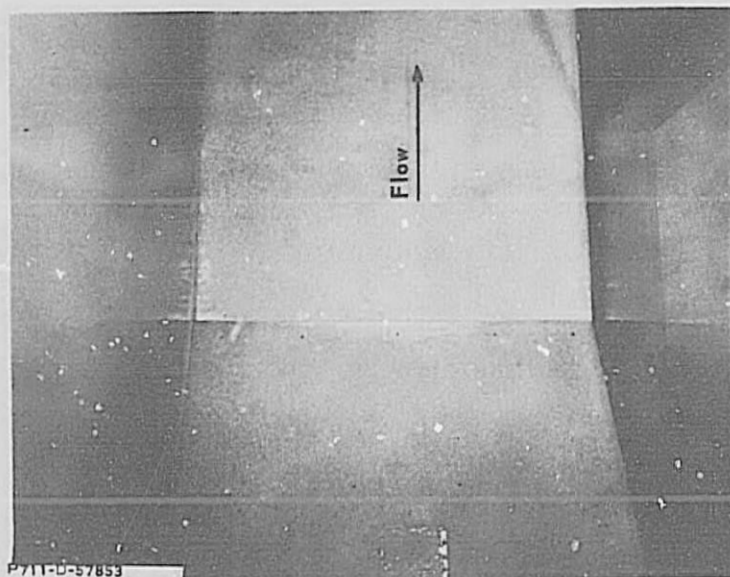
Chute and stilling basin floor abrasion after 5-1/2 hours at $Q = 2,500$ cfs, reservoir elevation 6085.
